**Wrights Road Storage Ponds  
– Dam Safety Management  
Plan (Pre-Construction  
Issue)**

Prepared for Waimakariri Irrigation Ltd

| Document Title | Dam Safety Management Plan (Pre-Construction Issue) |

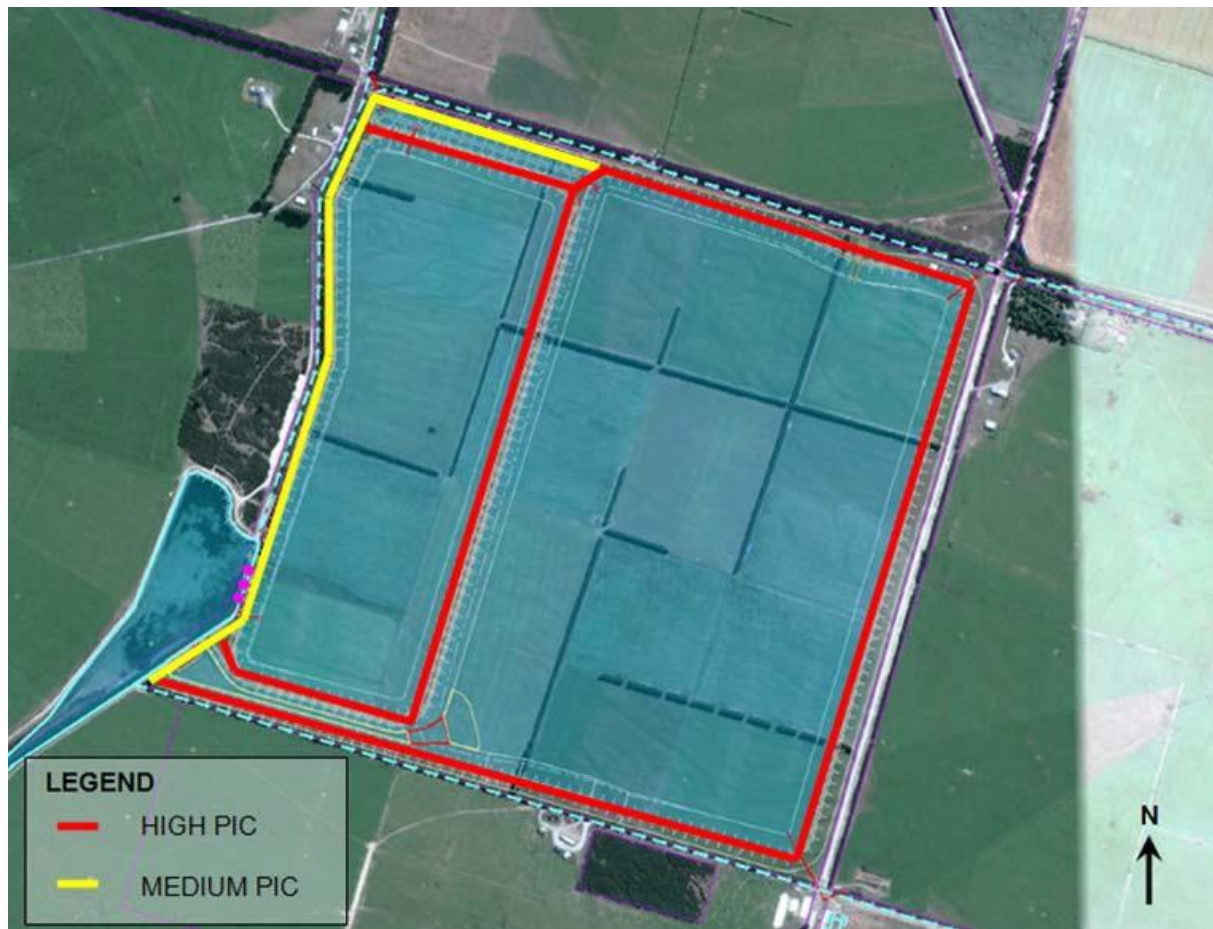
**Figure 1 - PIC Classification for the Wrights Road Irrigation Storage Pond Embankments**

The Wrights Road Ponds are classified as “large” dams under the Building Act and the Potential Impact Classification (PIC) has been assessed as “MEDIUM” and “HIGH”. This follows the basic principle that different Potential Impact Classifications can be applied to discrete lengths of the pond embankment, as the downstream consequences of breach vary depending on the embankment section breached. It follows that a breach of the west embankment would have less consequence than a breach of any of the other embankments (refer Figure 1). PIC only reflects the potential impact that hypothetical failure of the dam could have on downstream people, property and the environment.

| Parameter | Data | | | |
|---|---|---|---|---|
| Potential Impact Classification (PIC) | HIGH with some embankments being MEDIUM (see Figure 1) | | | |
