## Waimakariri Irrigation Scheme Storage Ponds - Potential Impact Classification

Waimakariri Irrigation Ltd

**Issue 3**

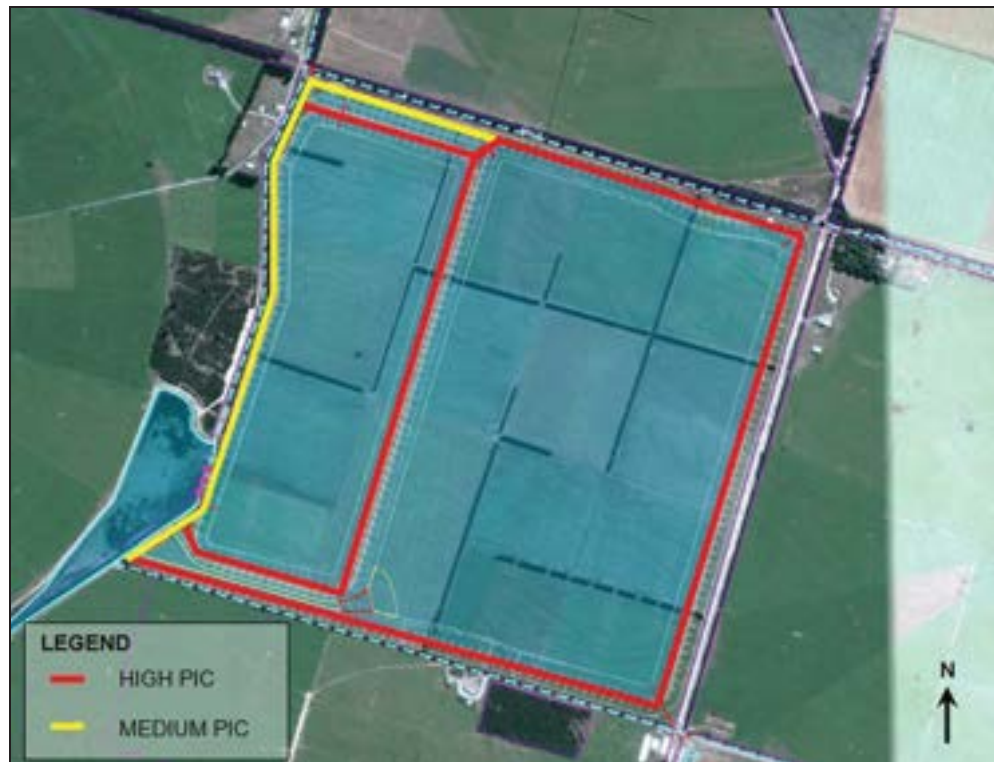
**Figure A1 - Summary of PIC assessment for embankments of proposed Waimakariri Irrigation Limited storage ponds, with revised PIC for the Tub embankments.**

The external embankment of the Tub is therefore reclassified from a High to a Medium PIC, based on the reasons outlined above. Figure A1 presents the PIC for discrete sections of the pond embankments, taking the revised PIC for the Tub external embankment into account. This figure supersedes Figure 2 presented in the main report.

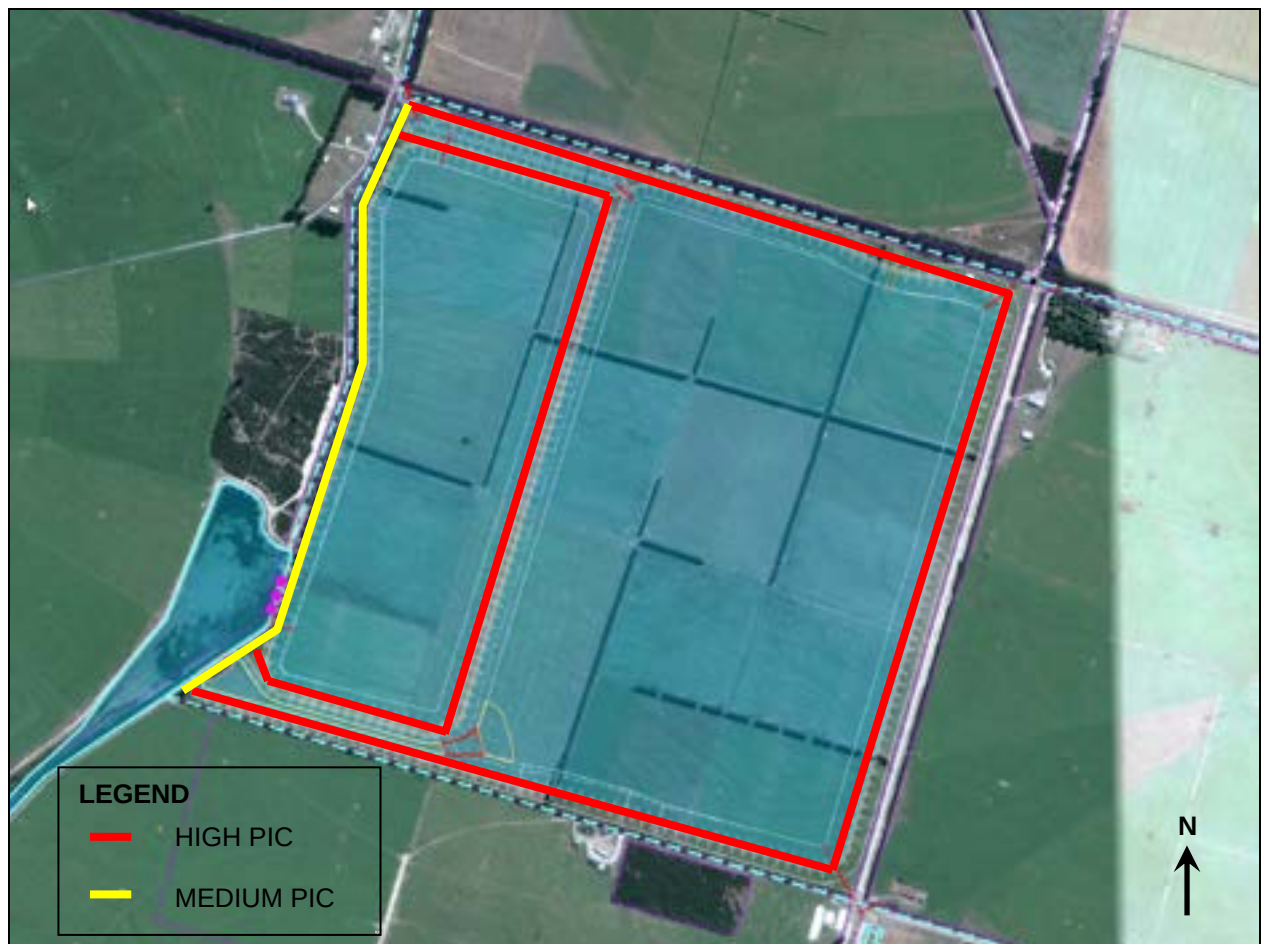
**Figure 2 – Summary of PIC assessment for embankments of proposed Waimakariri Irrigation Limited storage ponds**

A fundamental principle proposed for Waimakariri Irrigation Storage ponds is that different Potential Impact Classifications can be applied to discrete lengths of the pond embankment, because the downstream consequences of breach vary depending on the section of the embankment breached. It follows that breach of the west embankment would have less

consequence than breach of any of the other embankments. Accordingly, we submit that for the proposed Waimakariri Irrigation Limited storage ponds, discrete sections of the embankment can be assigned a different PIC as is done with large canal embankments. This then results in different standards for design and construction of discrete sections of the pond embankments, as summarised in Figure 2.

1. Design, construction and operation standards of the proposed Waimakariri Irrigation Limited storage ponds are based on a PIC assessed in accordance with the Building (Dam Safety) Regulations method set in accordance with NZSOLD Guidelines.
2. That the embankments are assessed with a PIC determined by the consequence of a breach, which for the western embankment is a MEDIUM PIC and for all other embankments a HIGH PIC, as summarised in Figure 2.

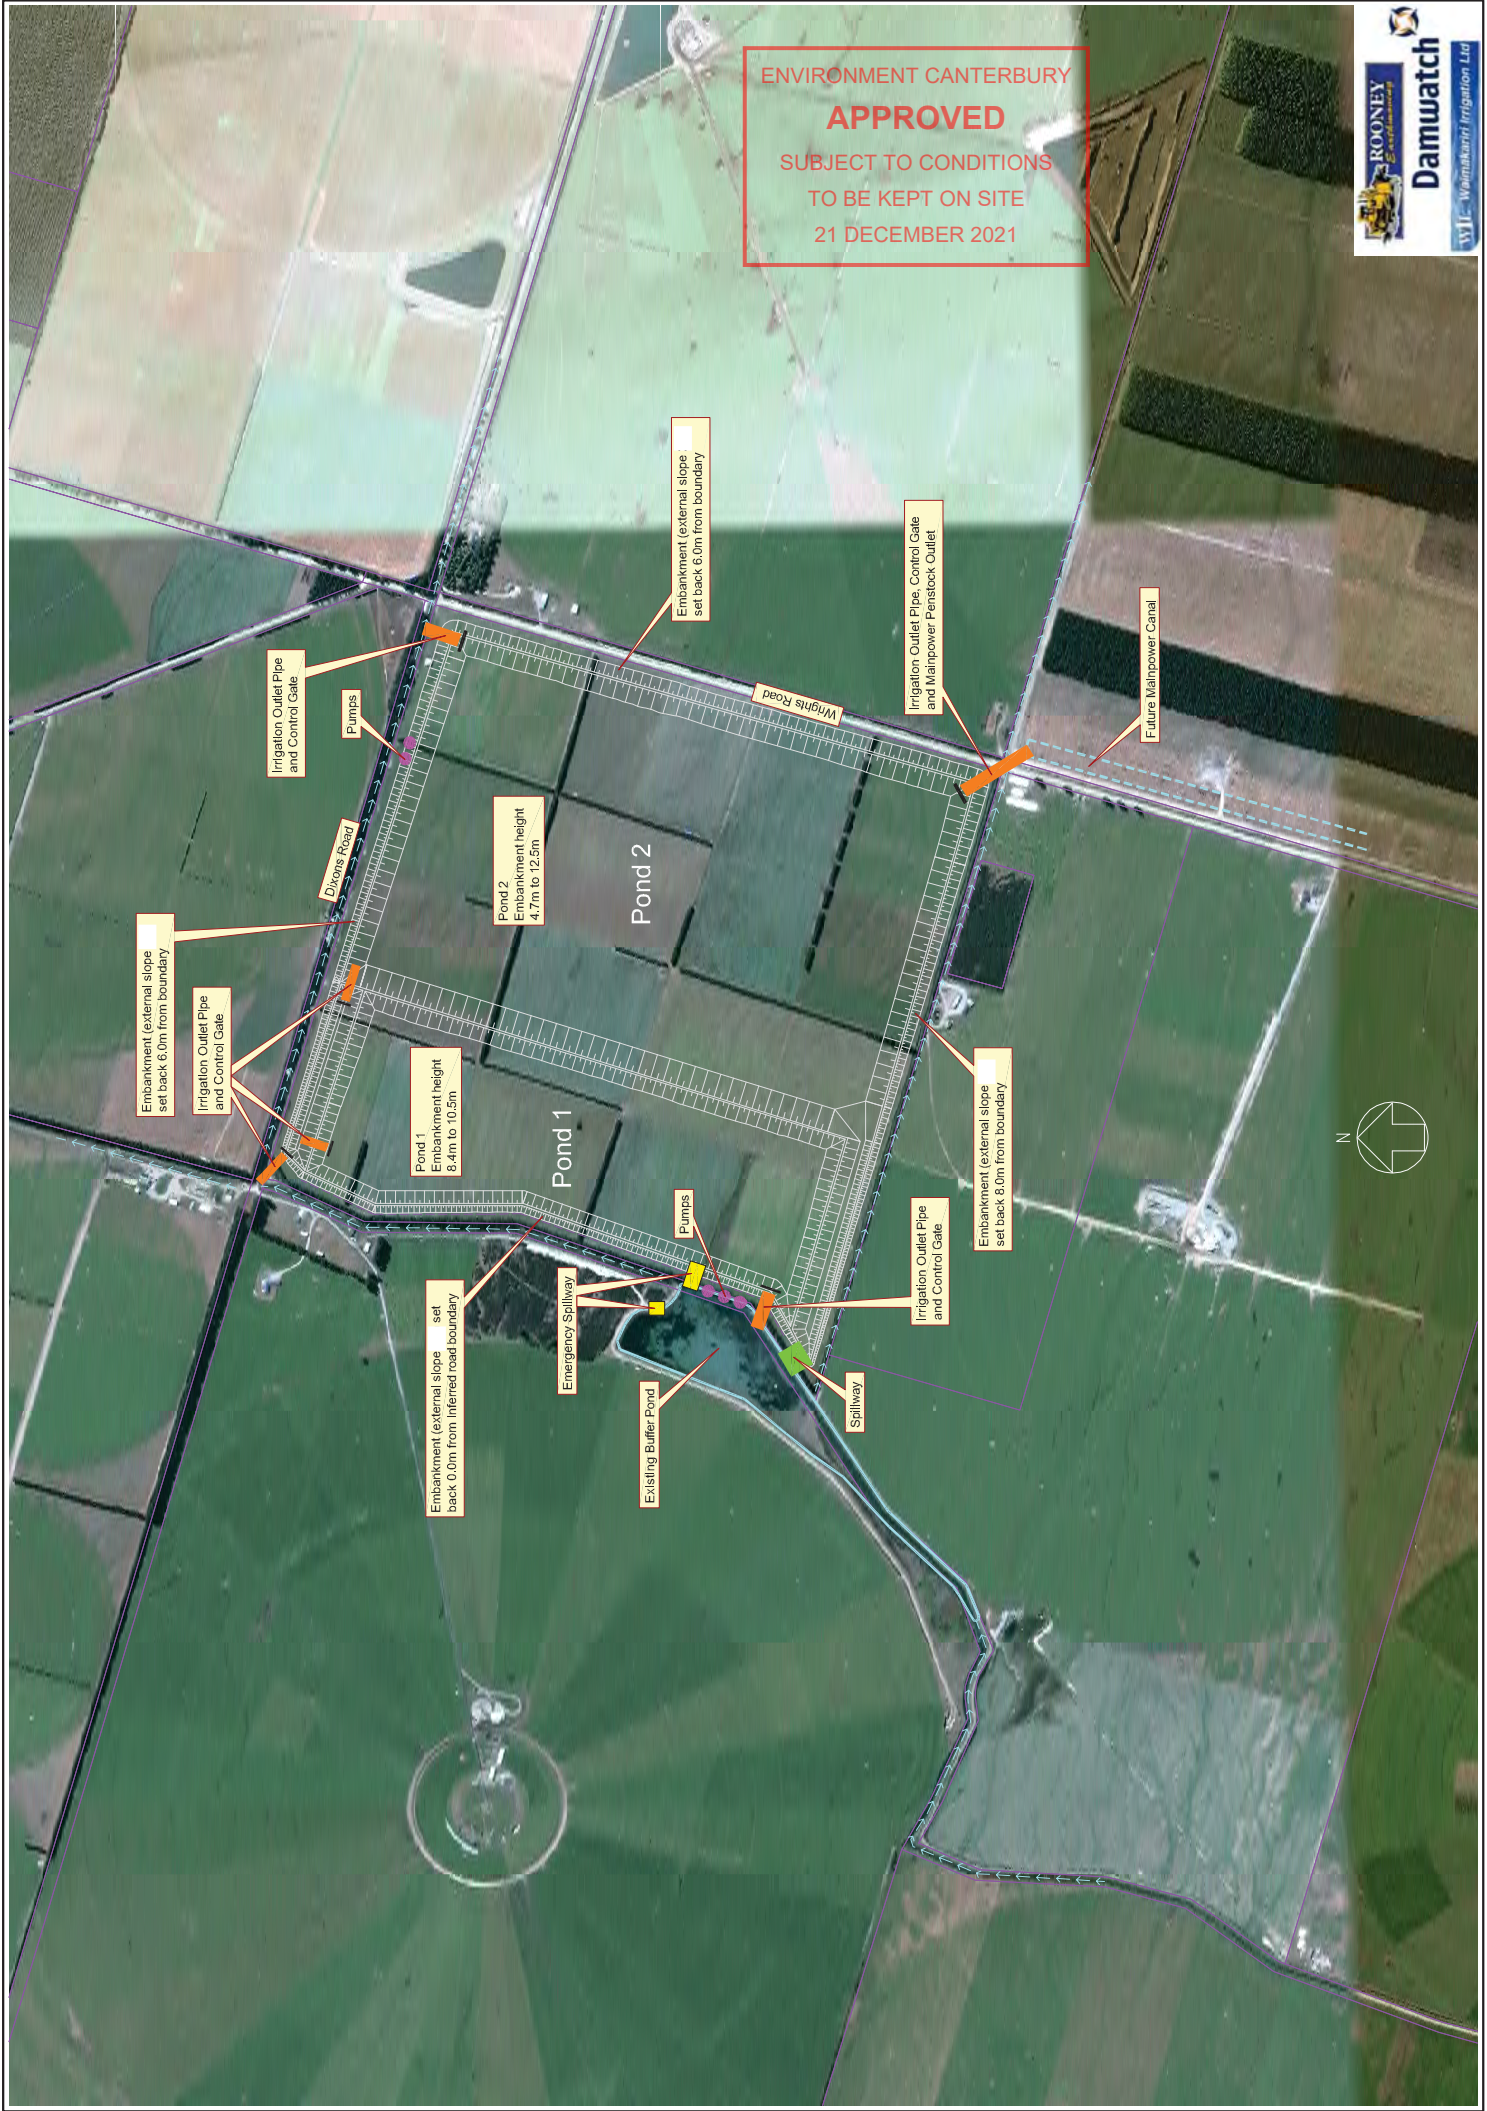
Figure 1 – Layout map of proposed Waimakariri Irrigation Limited Storage Ponds

The proposed site for the proposed Waimakariri Irrigation Limited (WIL) scheme storage ponds is located between the Waimakariri River and the Eyre River on the Canterbury Plains. The proposed storage scheme consists of two conjoint ponds, as indicated in Figure 1 of Appendix A. The proposed reservoirs will be impounded by lined earthen embankments. The maximum dam height and storage volumes are listed in Table 1. Each pond is a large dam according to the definition of the Building Act (2004), as each pond has a depth of water greater than 3 m and a reservoir volume greater than 20,000 m<sup>3</sup>.

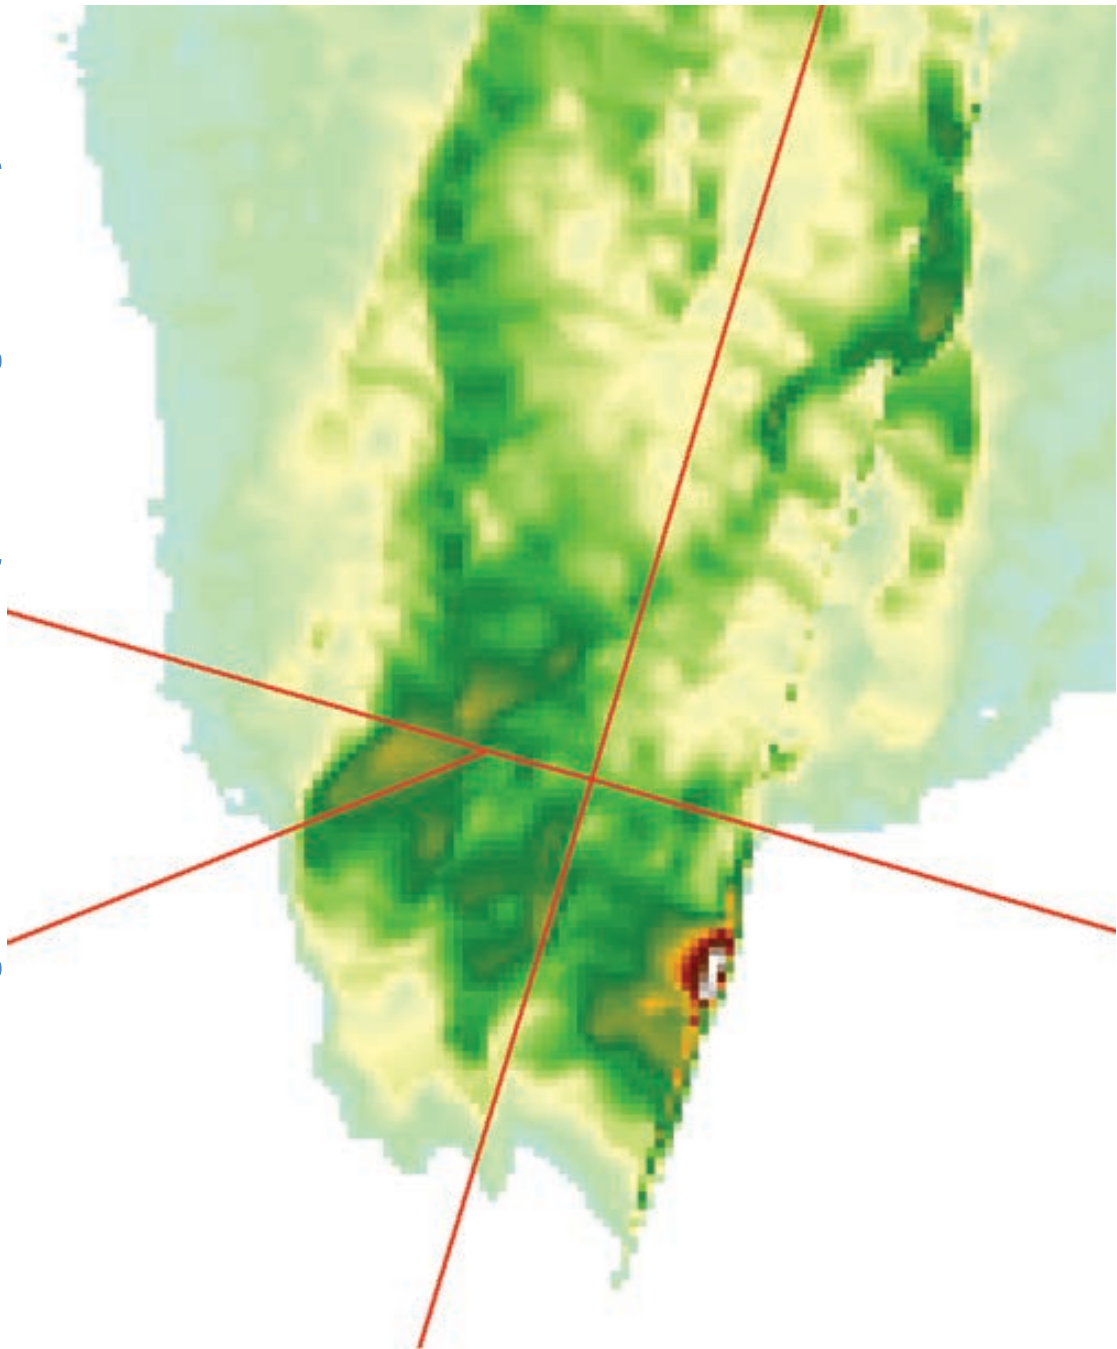
Detail, extent of flooding from north-side breach (also showing local roads)
