REPORT

**Waimakariri Irrigation Ltd
Storage Ponds – Dam Safety
Management System (Pre-
Construction Issue)**

22 February 2017

Issue 4.1

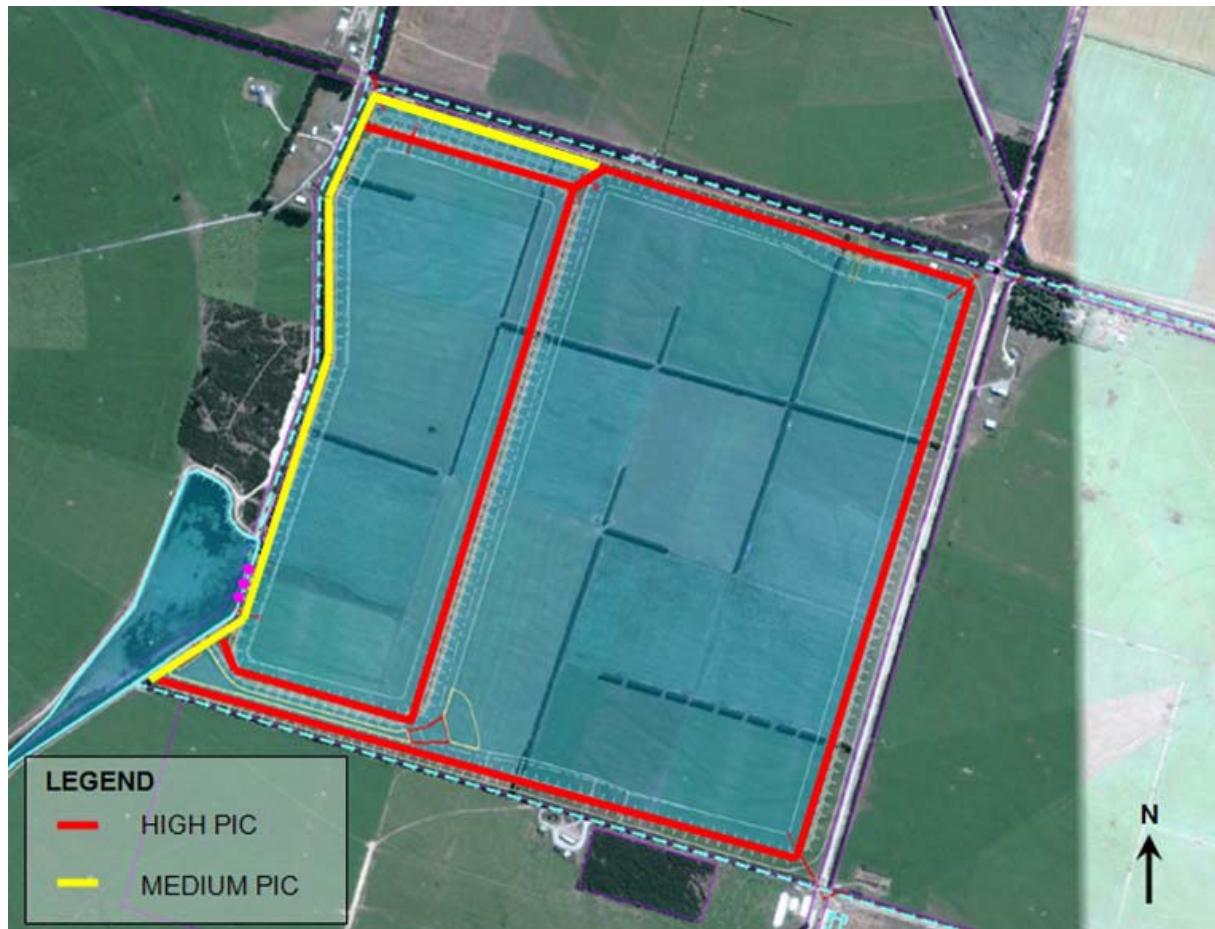
The Waimakariri Ponds are classified as “large” dams under the Building Act and the Potential Impact Classification (PIC) has been assessed as “MEDIUM” and “HIGH”. This follows the basic principle that different Potential Impact Classifications can be applied to discrete lengths of the pond embankment, as the downstream consequences of breach vary depending on the embankment section breached. It follows that a breach of the west embankment would have less consequence than a breach of any of the other embankments (refer Figure 1). PIC only reflects the potential impact that hypothetical failure of the dam could have on downstream people, property and the environment.

Figure 1 - PIC Classification for the Waimakariri Irrigation Storage Pond Embankments

Parameter	Data			
	Pond 1	Pond 2	Buffer Pond	The Tub
Dam name	Waimakariri Storage Ponds 1 & 2			
Dam location (NZTM)	1534683mE, 5196928mN			
Dam type	Geo-membrane lined earth embankment			
Potential Impact Classification (PIC)	HIGH with some embankments being MEDIUM (see Figure 1)			
Construction period	Approximately 2 years			
Type of spillway	Free Overflow			
Service spillway (S1) crest level	-	RL 222.5m		
Service spillway (S1) capacity	-	17.0 m ³ /s		
Emergency spillway crest level	RL 227.2m (E1)	-	RL 223.5m (E2)	RL 223.5m (E3)
Emergency spillway capacity	-	-	17 m ³ /s	17 m ³ /s
Fuse plug spillway capacity			60 m ³ /s	
Embankment slopes	Inside = 3H:1V Outside = 2.5H:1V = 2H:1V Pond 1 north embankment

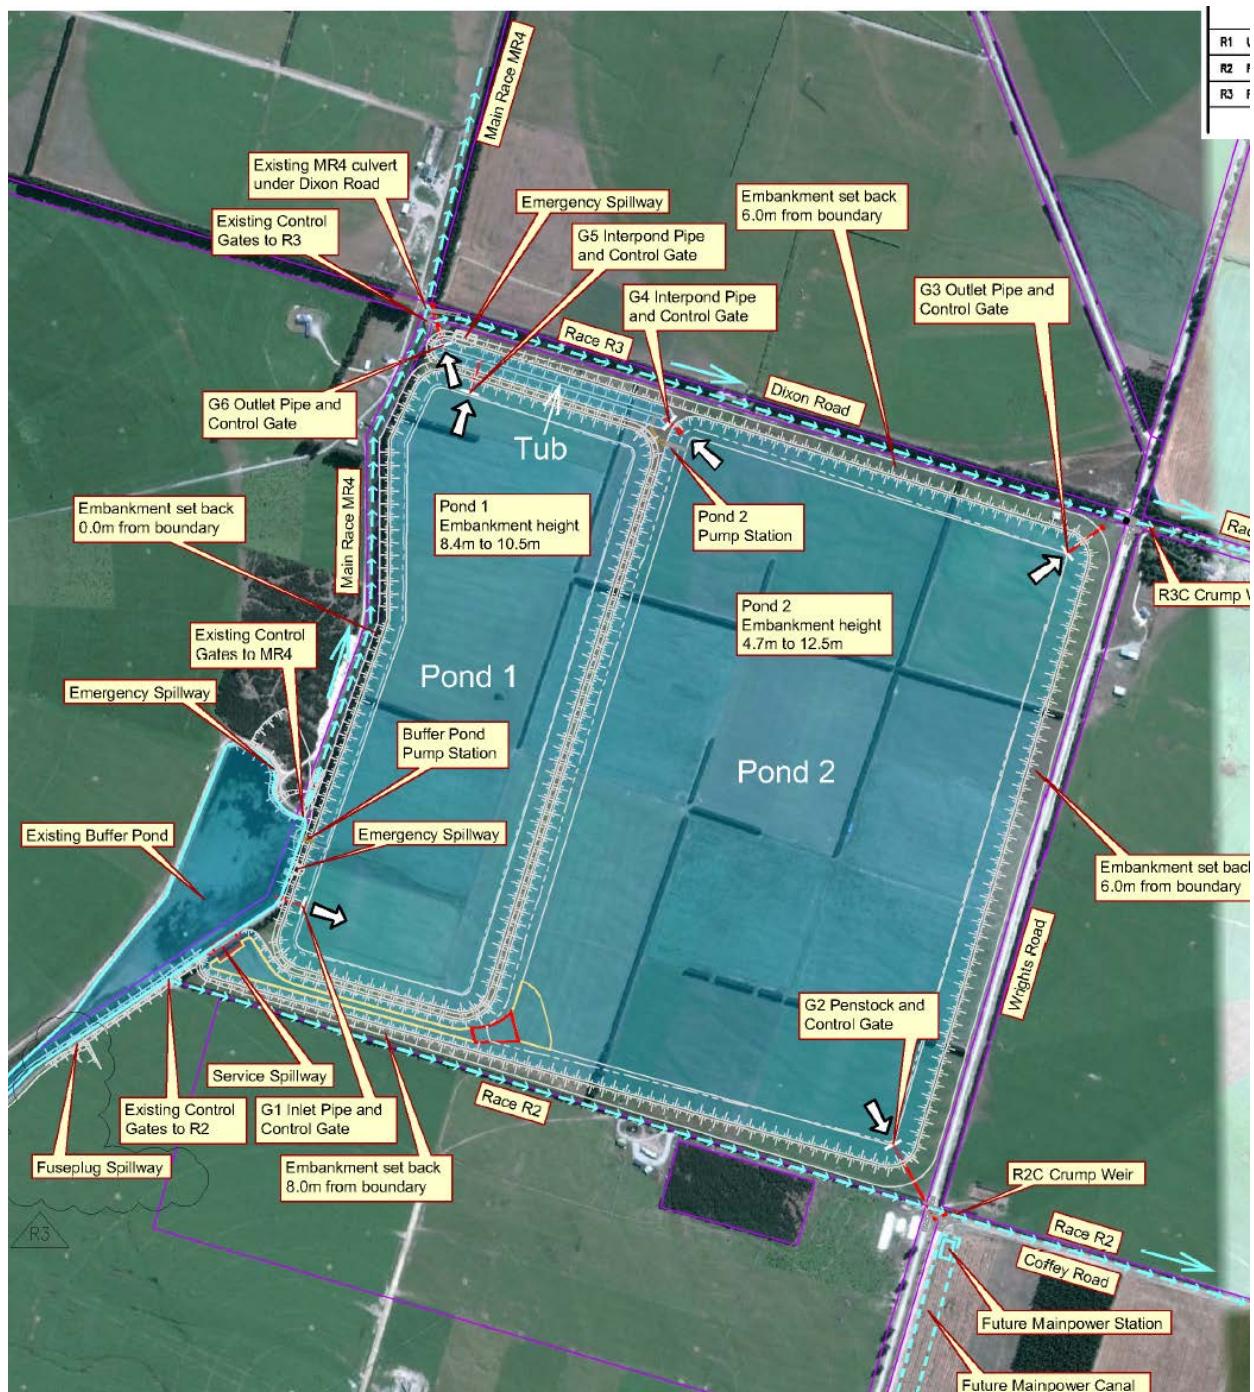
A general overview of the ponds is shown in Figure 3. Selected detailed general arrangement drawings are included in Appendix B.

Figure 3 – Waimakariri Ponds and Appurtenant Structures

This plan includes the embankments that form the two ponds along with their appurtenant structures (refer to Figure 3), which are:

The component locations are shown in Figure 3 and Dwg WIL1125/30/1 and WIL1125/30/21-23 in Appendix B.

Pond 1 is initially filled by gravity via the inlet gated culvert G1 (refer to Figure 3). Filling priority is to Pond 1 as it has the facility to augment water in the main race MR4.

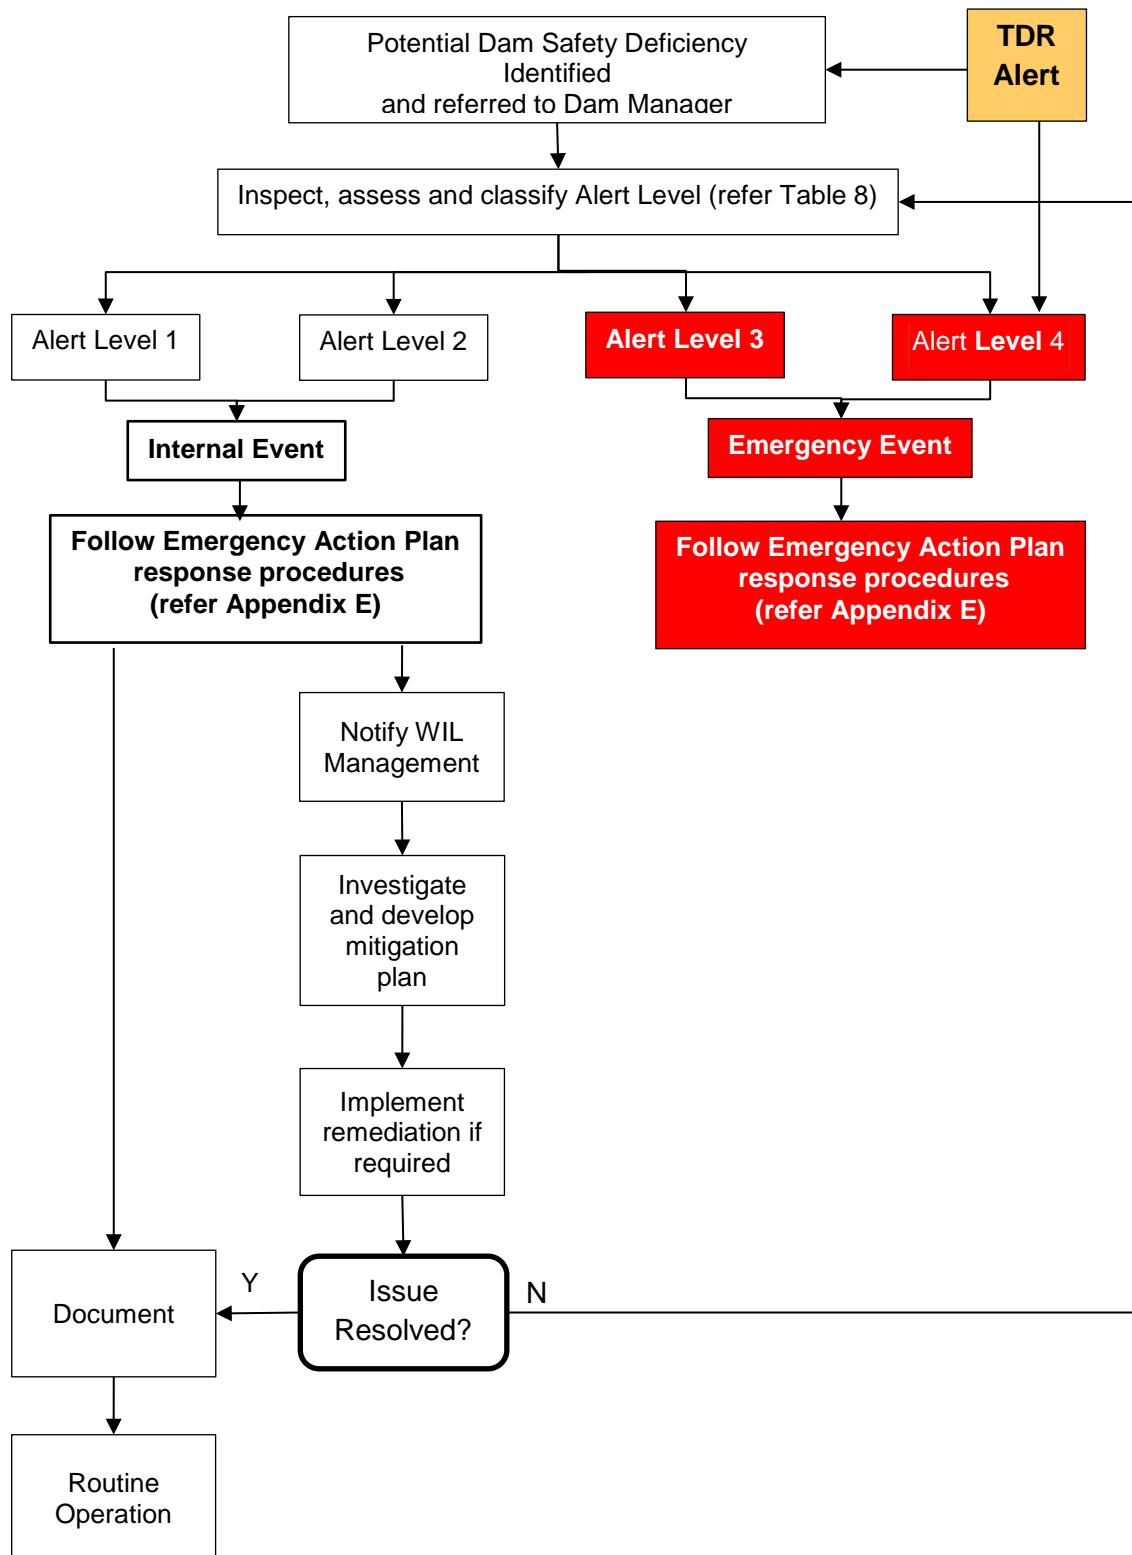
Figure 5- Emergency Action Plan Implementation Chart

Anomalies or alarms raised during the routine or special inspections shall be treated as potential dam safety deficiency and shall be assessed in accordance with Table 8 and Figure 5.

For all identified concerns or dam safety deficiencies, the WIL Dam Manager, with advice from the Dam Safety Advisor, will classify the event in accordance with Table 8 below. The WIL Dam Manager will then arrange for the appropriate notifications and actions to be carried out. All incidents shall be registered and monitored in the pond incident database. Figure 5 provides an overview flow chart of the process for the management of an incident.

A Time Domain Reflectometry (TDR) system is installed in the dam crest around the embankment perimeter (refer to drawing WIL1125/30/25). This system is capable of providing an alert if the TDR cable is sheared, indicating a large magnitude slope failure. Figure 5 shows how the TDR alerts are managed under the Emergency Action Plan.
